# Shire of Merredin

## Merredin Water Tank

### Inspection Findings

June 2019

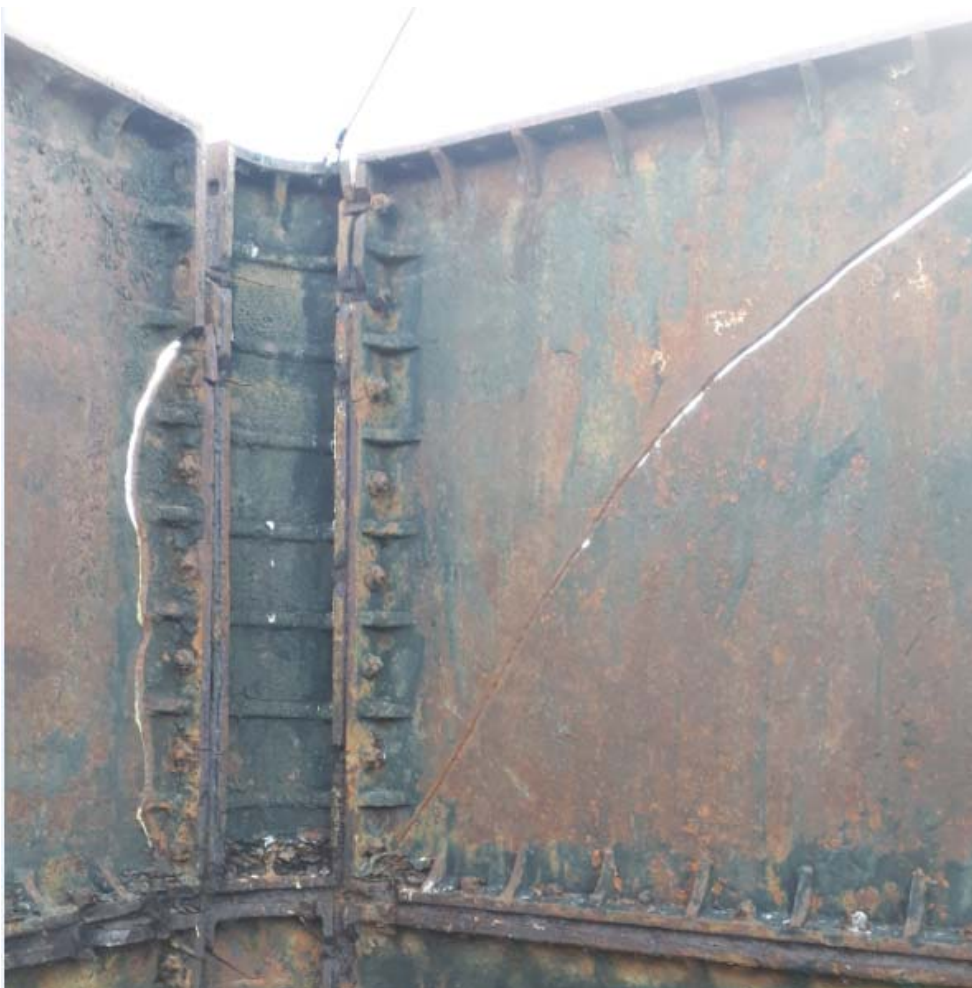
Figure 1 Vertical and diagonal cracks

- Vertical and diagonal cracks were observed on four cast iron panels at the south and east sides of the tank's wall. Refer to Figure 1 below for an example of this. This failure mode may be due to compression and tension forces caused by thermal stress on the empty tank acting along the wall and the restraint offered by corner resulting in a longitudinal crack. Once a crack has initiated, it may travel along the width of the panel. In some instances cracks have formed on corner sides of the cast iron panels near the bolt joint connections.

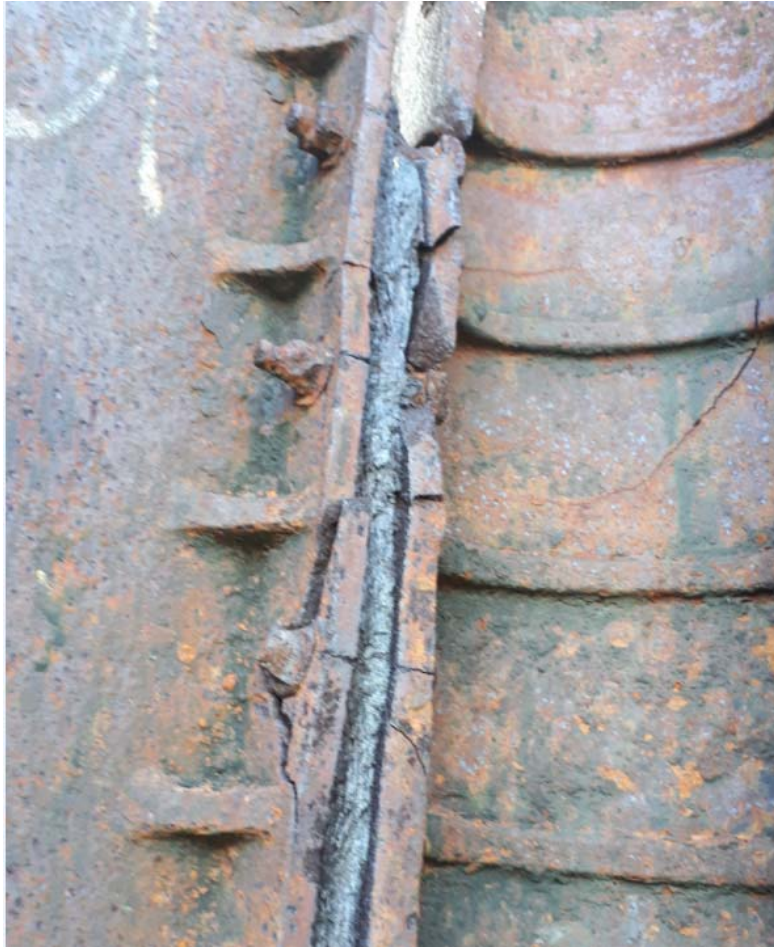
Figure 2 Cracks around bolt connections

- The majority of the bolt connections were failed as a result of cracking developed around the bolt joints as shown typically in Figure 2. The majority of the bolts were still held in place due to heavy rust formation around the bolts and the bolt holes.

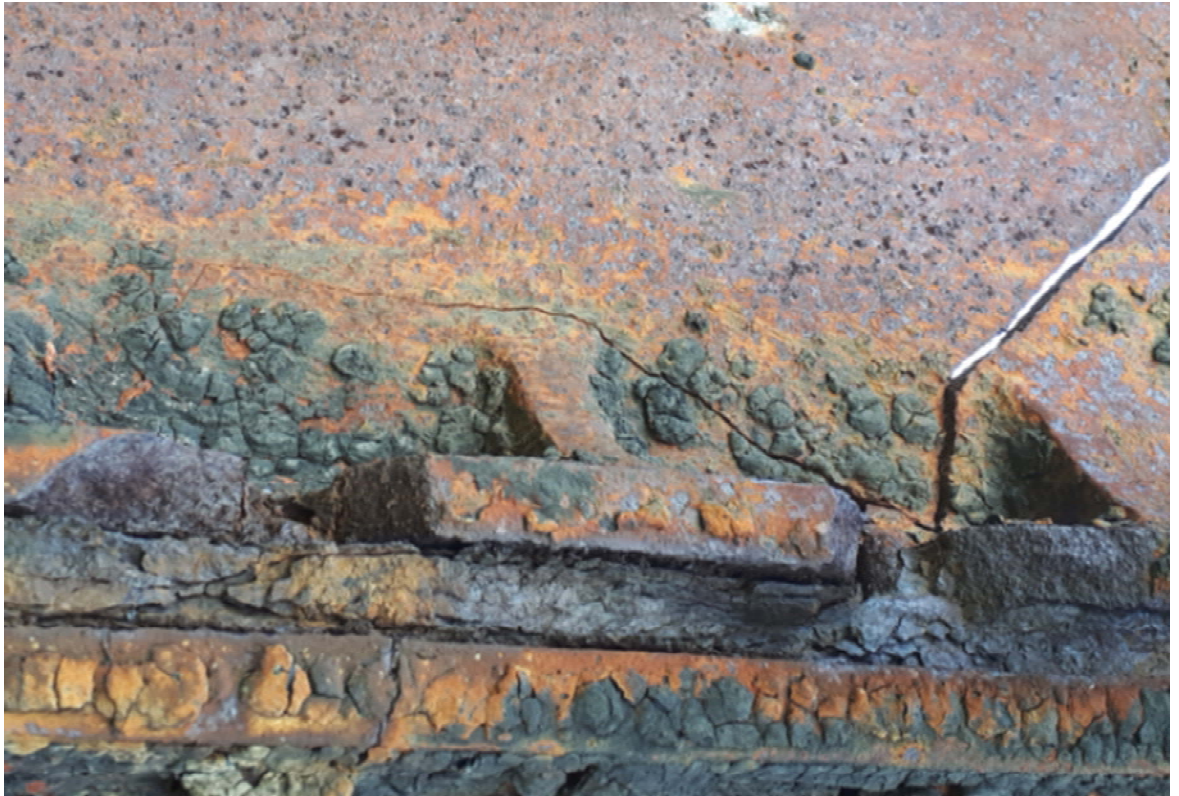
Figure 3 Packer plate expansion due to corrosion

- The interior surface of the tank were significantly rusted due to exposure to wet atmosphere.
- The carbon steel packer plates between the cast iron panels at joints were heavily corroded. The expansion due to rust formation of packer plates caused enough stress to create cracks within the adjacent cast iron panels. A typical photo is shown in Figure 3.

Furthermore the expansion forces caused by corrosion of packer plate i.e. up to six times of the original thickness, in turn creates cracks over time. As a summary, the root cause of damage is most likely due to:

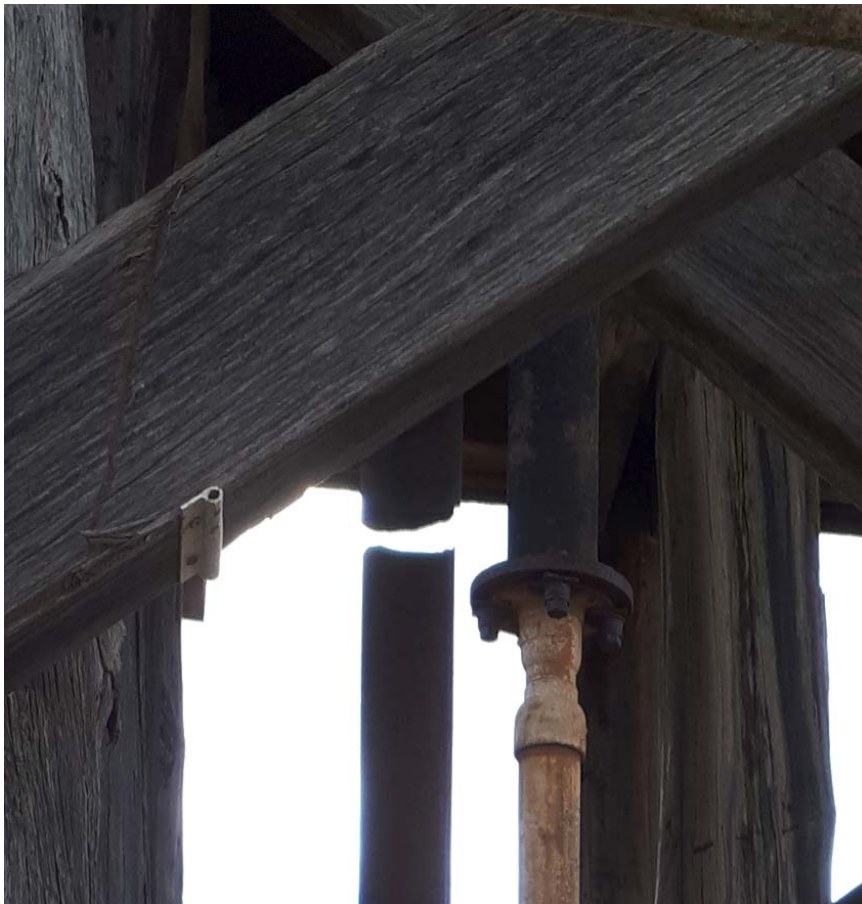
Figure 4 Circumferential crack on the cast iron pipe

- The cast iron pipe extended from the bottom of the tank to ground level was entirely separated in one location close to the bottom side of the tank. This has caused by circumferential cracking as shown in Figure 4. Circumferential cracking is the most common failure mode for small diameter (<380 mm diameter) gray cast iron pipes. Typically this type of failure is caused by bending forces applied to the pipe. The resulting failure occurs in a manner similar to a twig snapping, with the failure crack propagating across the circumference of the pipe. This type of failure could also be caused by soil movements producing tensile forces on the pipe, producing a simple tensile failure. However no sign of soil movement was observed on the site around the tank stand foundation and pipe support.

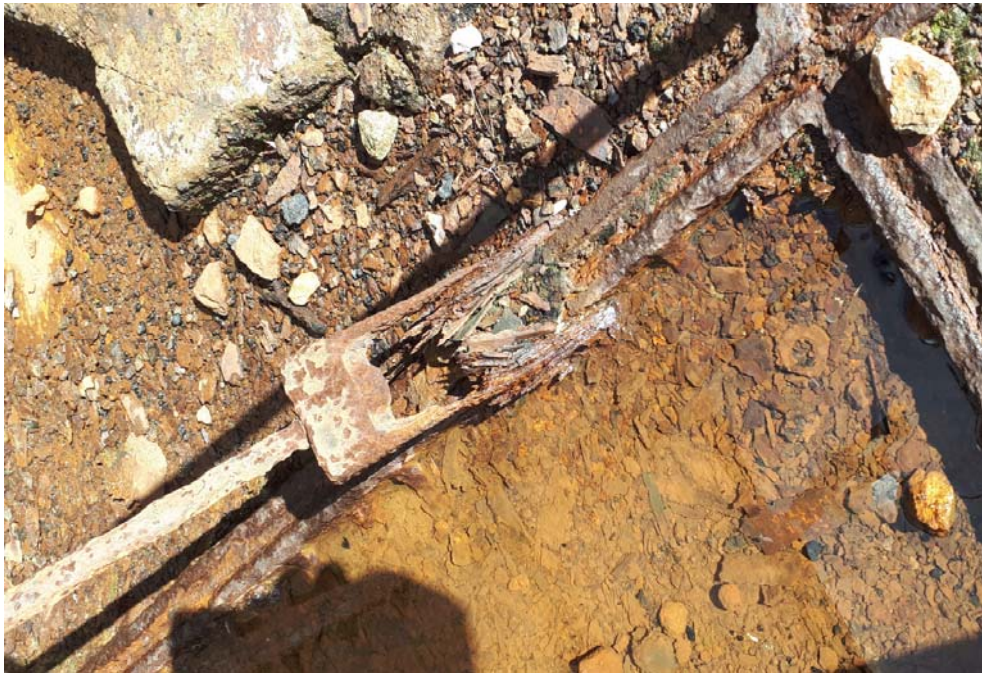
Figure 5 Heavy corroded tie rod connection cleats

- The tie rod connection cleats were heavily corroded (dysfunctional). A typical photo is shown in Figure 5.
- The floor cast iron panels were covered by concrete. Longitudinal cracks were observed on the floor panels where the concrete layer was removed.

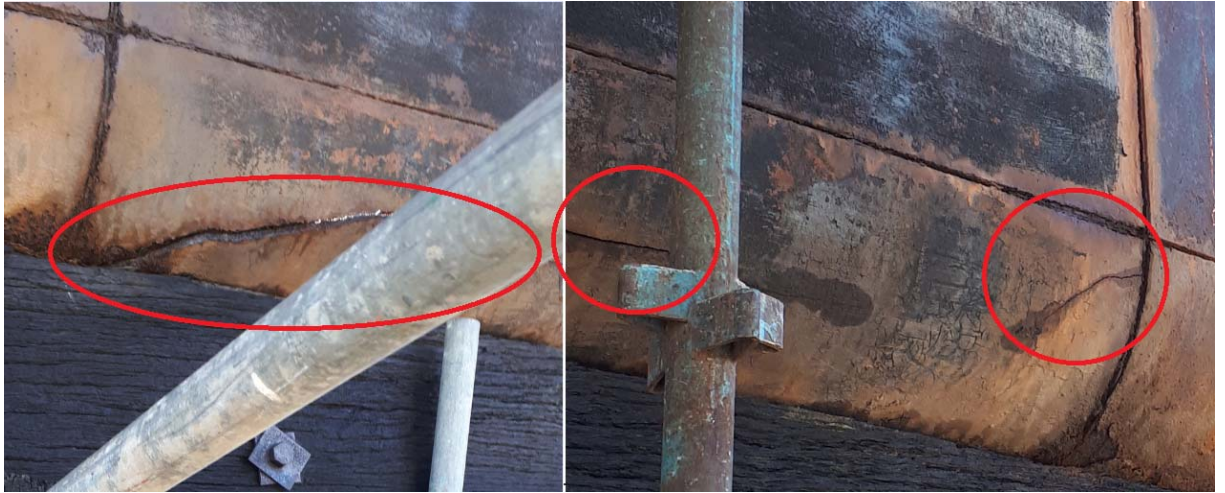
Figure 7 Cracks on the bottom joint panel

- Cracks were observed on several location at the bottom corners

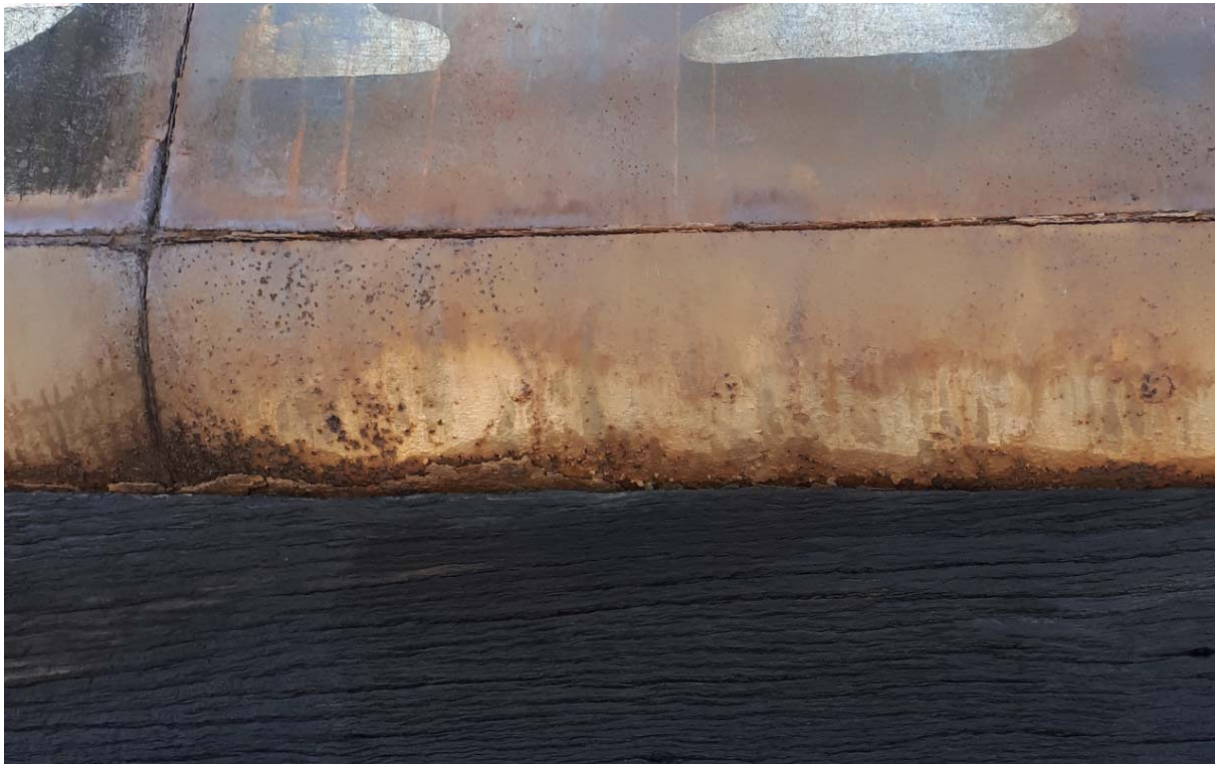
Figure 8 Significant rust on the interface between the tank bottom corner and timber beam

- The majority of joint connections and the interface between the tank bottom corners and timber beams were heavily corroded as shown typically in Figure 8.

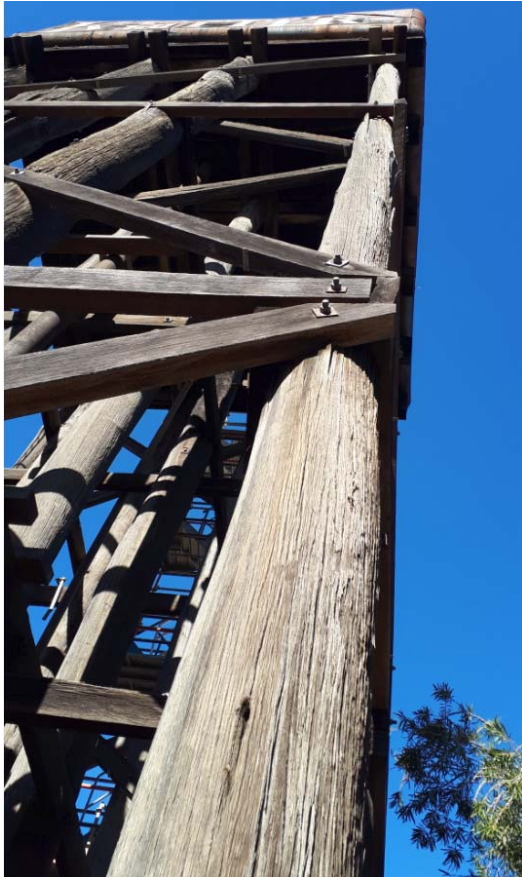
Figure 9 Tank Timber Columns

The tank stand was visually inspected from the ground level. The timber columns and cross bracings elements were reasonably in good condition with some missing bolts in joint connections. The timber columns were slightly deteriorated due to age and weathering. Weathering (wetting/drying) results in the creation of cracks but not splits the wood. The timber elements were structurally functional with no visible sign of biological attack (fungi and termites), fire and impact damage. No sign of movement or distortion were observed on the timber column foundation. A typical photos of tank stand and foundation are shown in Figure 9 and 10.
